Doc.-No.:AE-TD-01 Date: 20.02.2007 Revision: Rev. date:	Changes

Minor changes according EBH class 1. and 2.
 of TD 400 (Omega Tandem with Quick 400)

TD 400 (Omega Tandem with Quick 400)

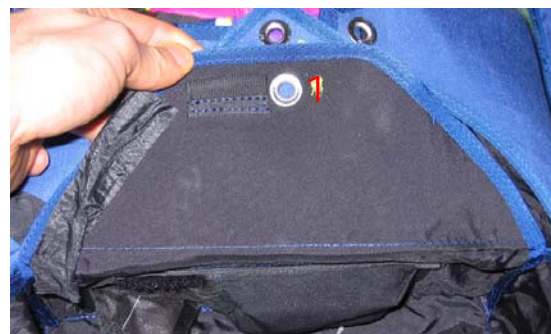
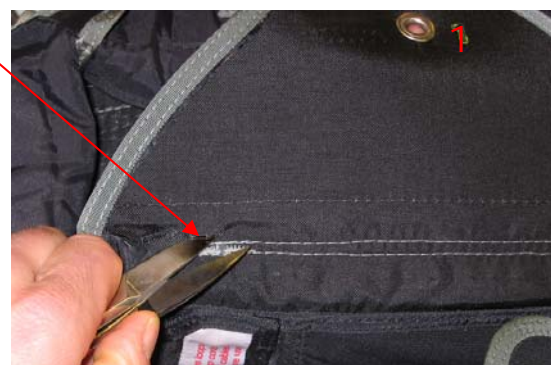
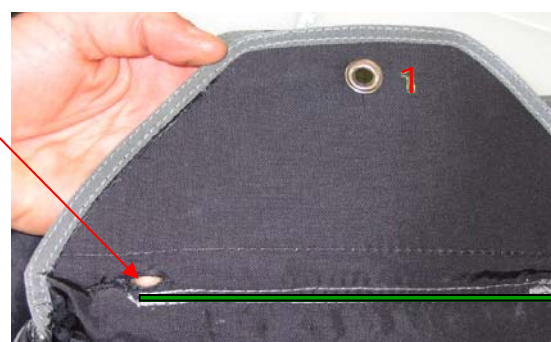
There must be cutted a small hole circa 15 mm in flap no.1 above the **attachement and bartec** of flap no. 3 (middel flap) and the edges of the hole must be melted with a lighter.

The already existing housing and cutter mount must be removed from flap no. 1.

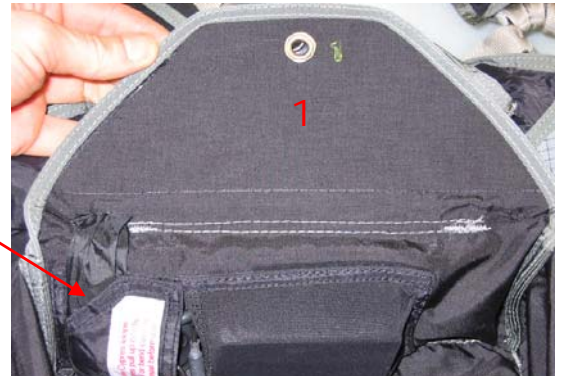
The fabric housing with mounted AAD.
