TECHNICAL ADVISORY

N° AV070716
Date 16/07/2007
Page 1/1

Advance Tandem system T1 and T2

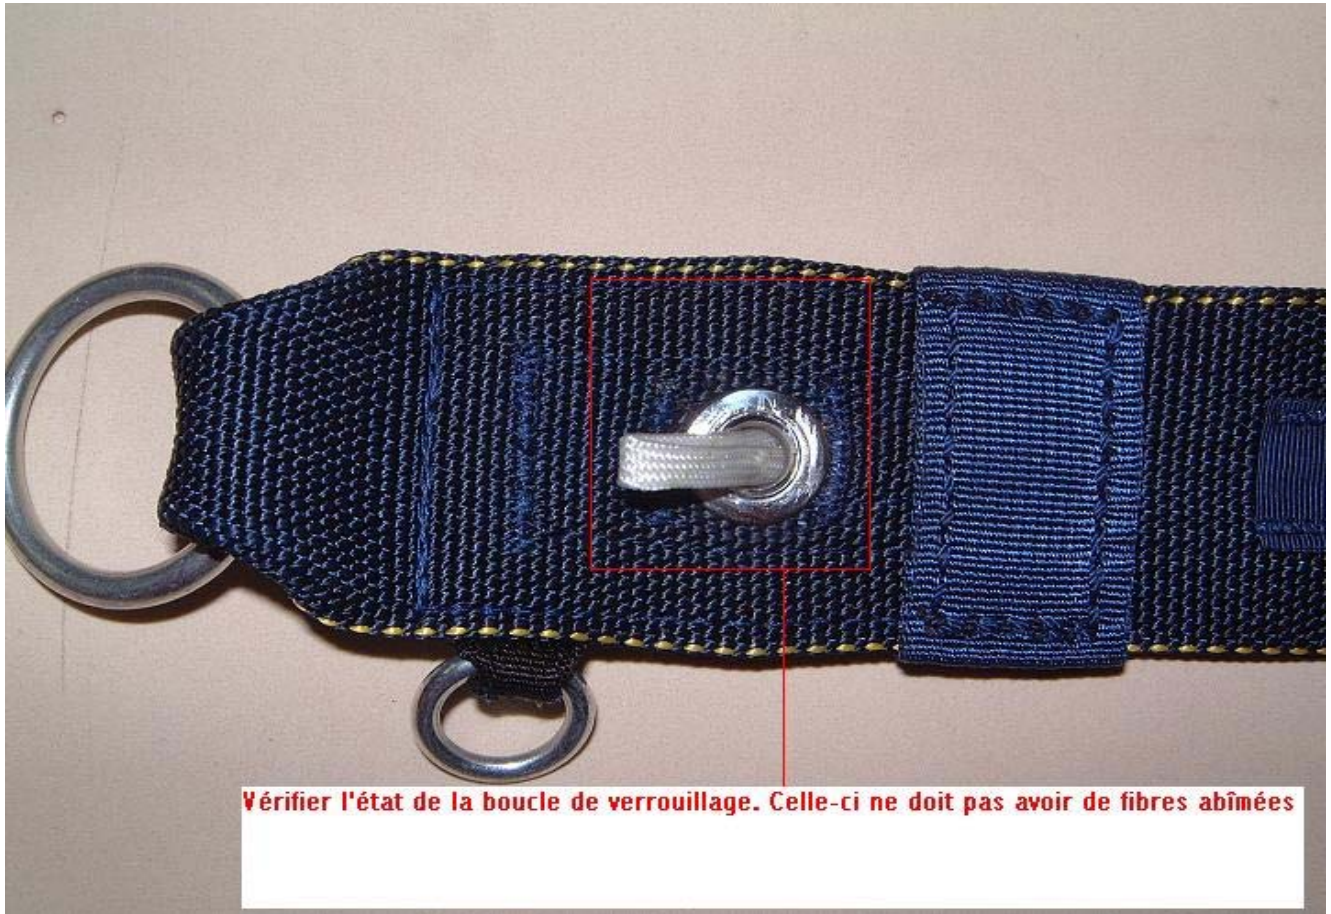
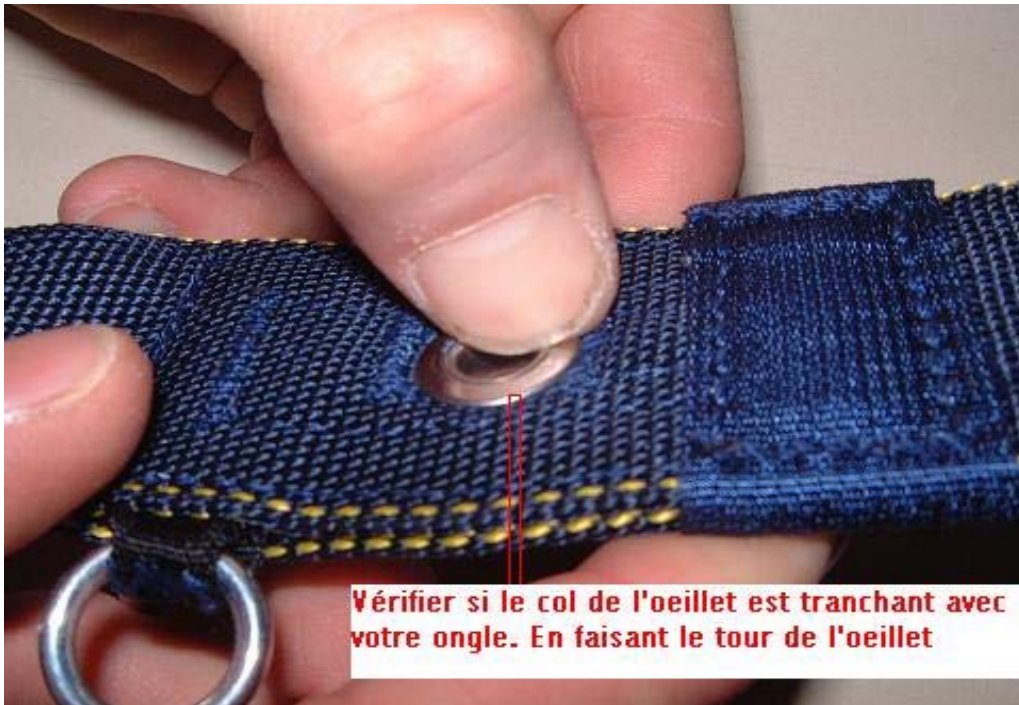
Reasons: Potential risk of white loop damage and even failure because of friction between the loop and the riser grommet.

Works: Visual control of the locking loop. None of the fiber must be damaged (photos). Verify the riser grommet as shown on the photos by checking de grommet edge. If sharp edge, check the evolution of the white loop and polish the grommet edge with a Dremel kind tool.

Subject It is request to all Advance tandem user to verify the white locking loop of the cutaway system on the main risers. Grommets must be check as well.
